RE: Milliken and Company – Hillside Plant
LaGrange, Troup County, Georgia
Site Inspection Report

SITE INSPECTION

**MILLIKEN & COMPANY – HILLSIDE PLANT
LAGRANGE, TROUP COUNTY, GEORGIA
GAD 981 275 993**

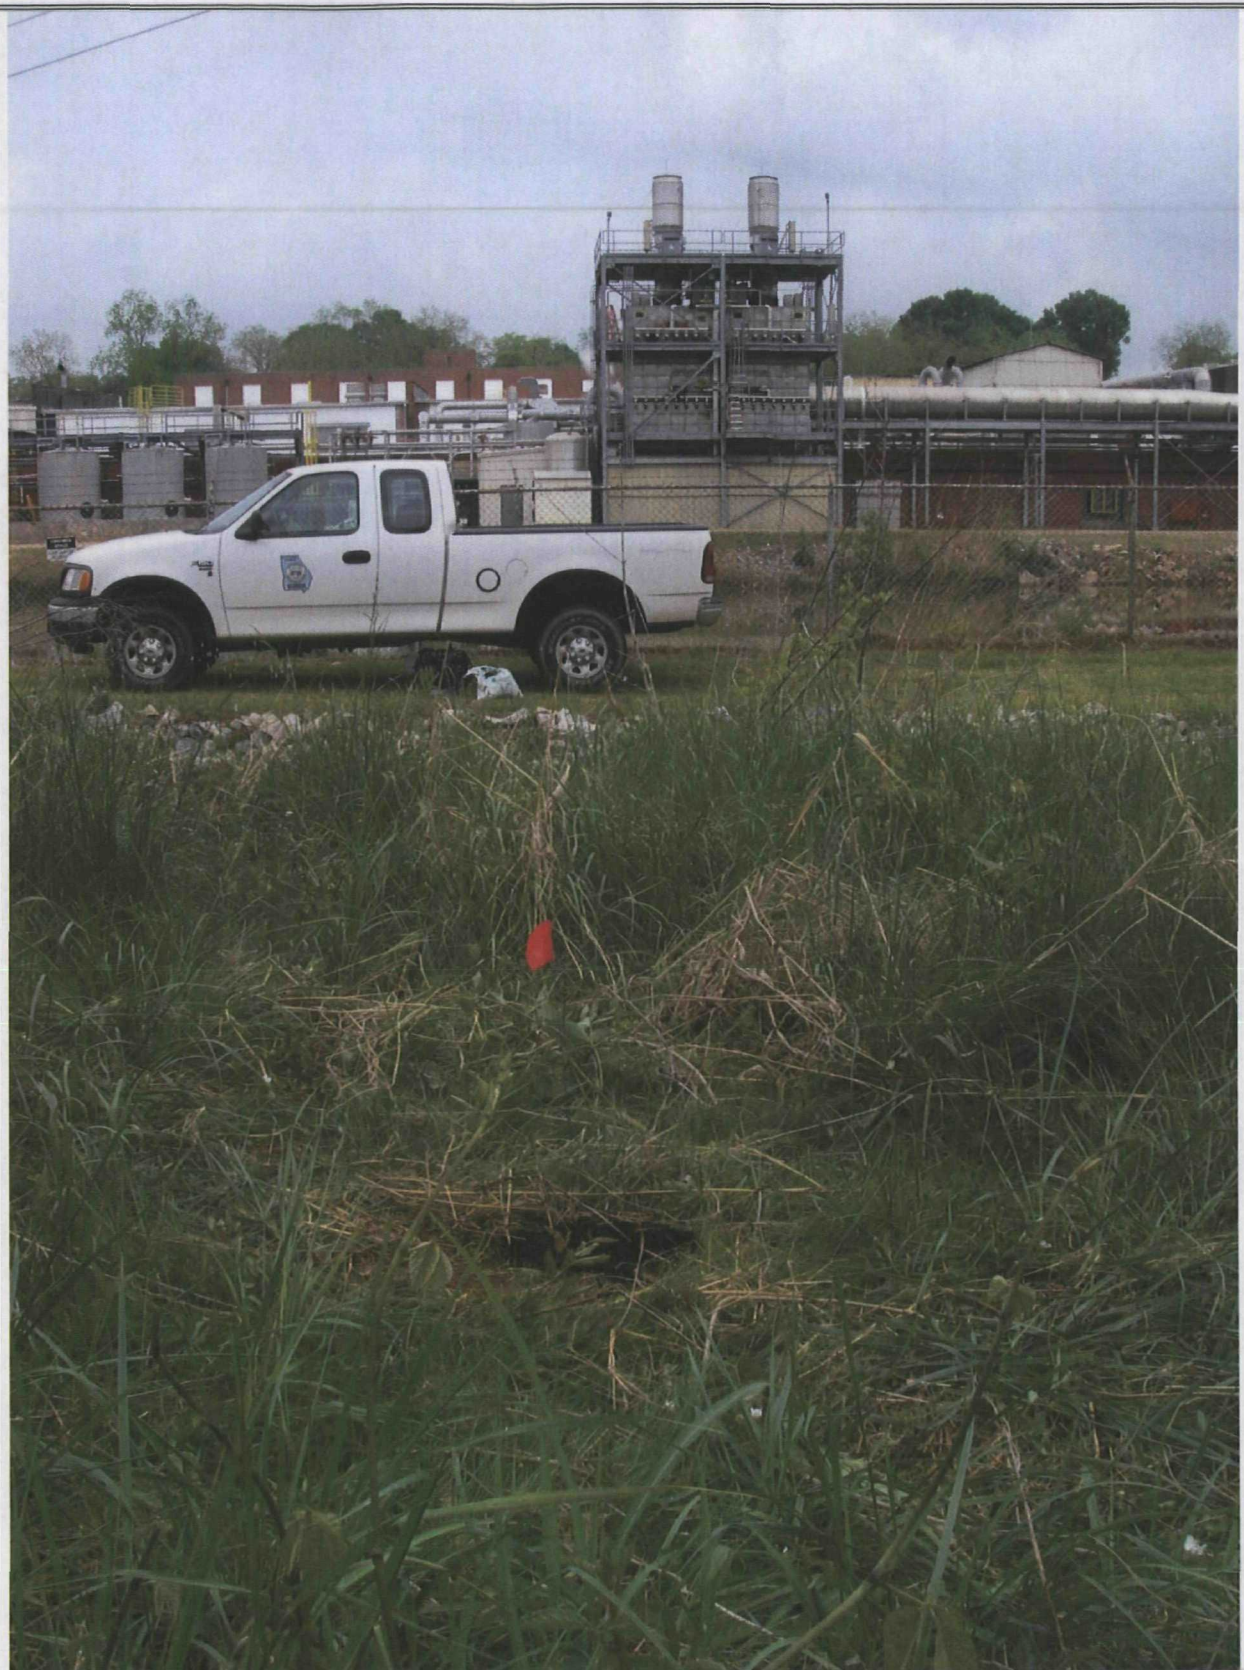
Depiction of immediate vicinity of where surficial soil samples were collected from on-site Sample Station Nos. STA-24-SS and STA-24-DUP (HW11007 and HW11008 respectively).

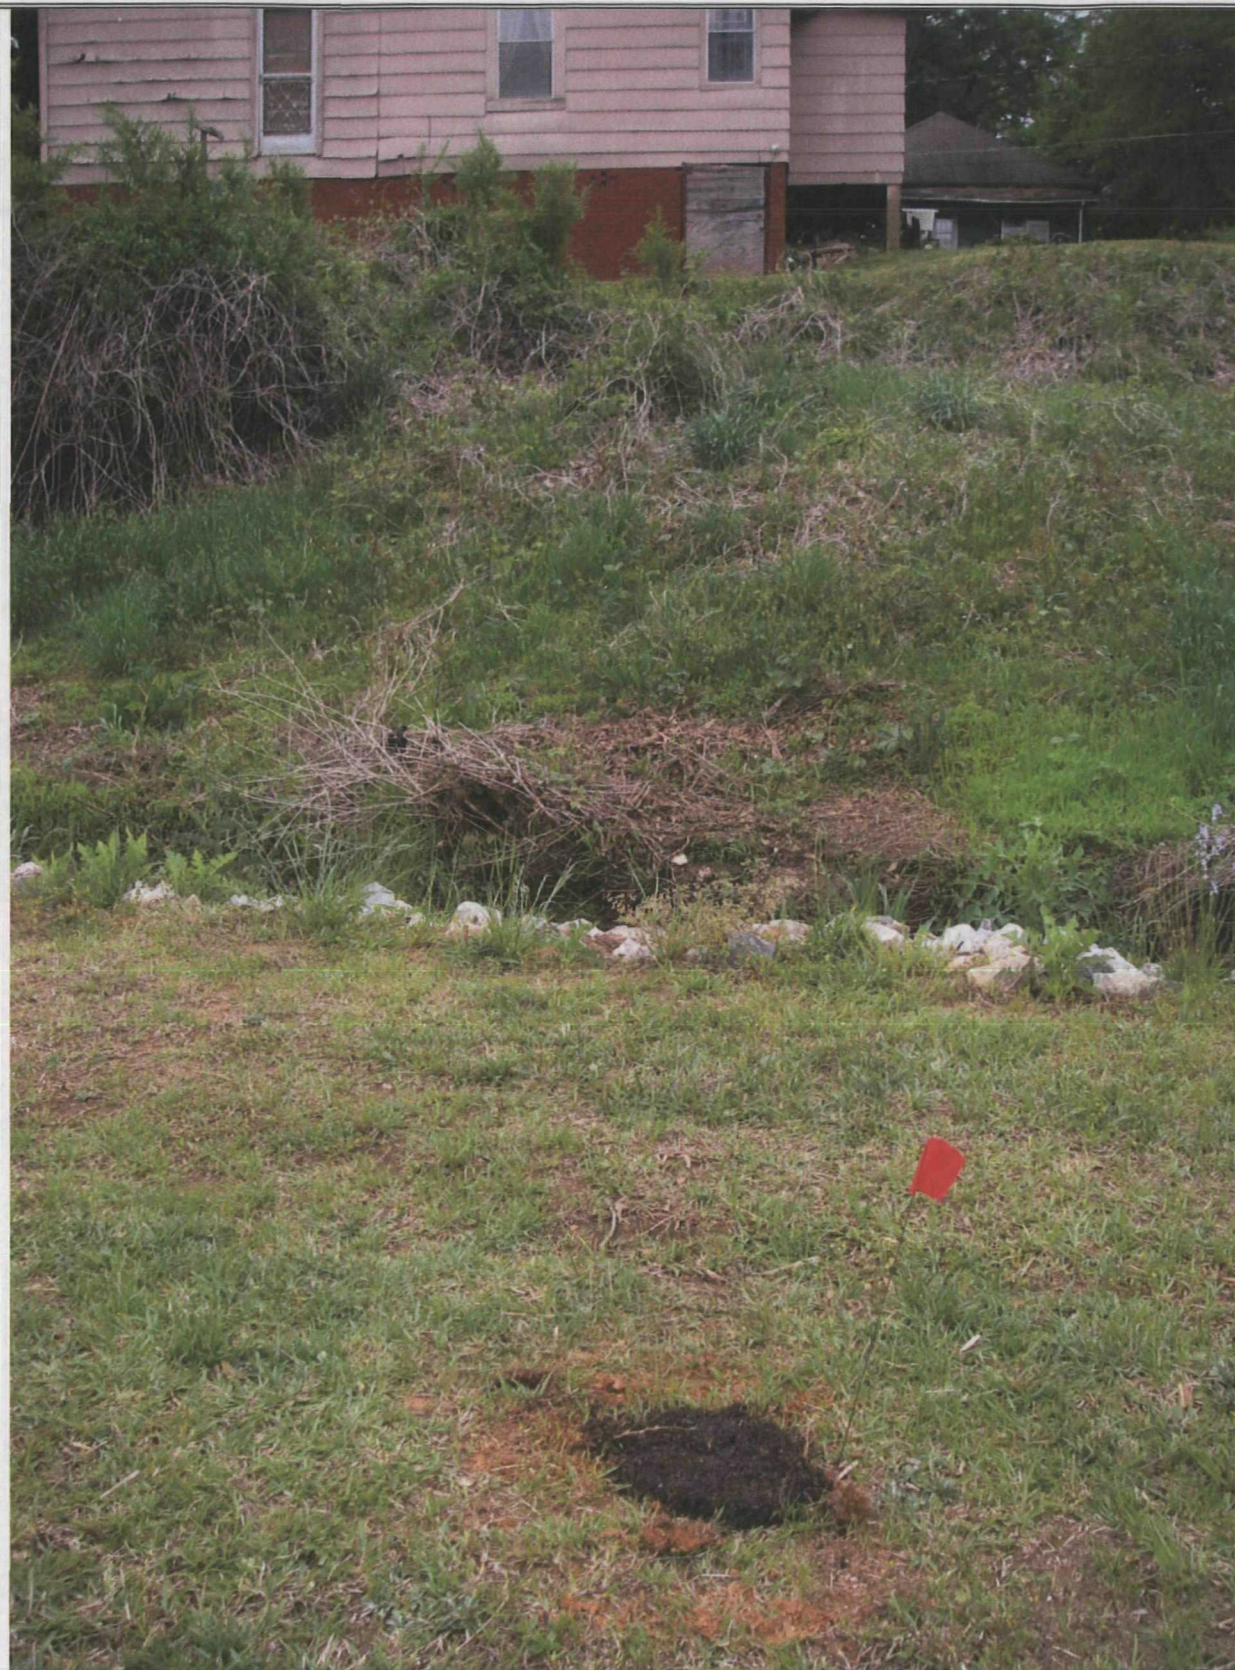
Depiction of immediate vicinity of where surficial soil sample was collected from on-site Sample Station No. STA-22-SS (HW11005).

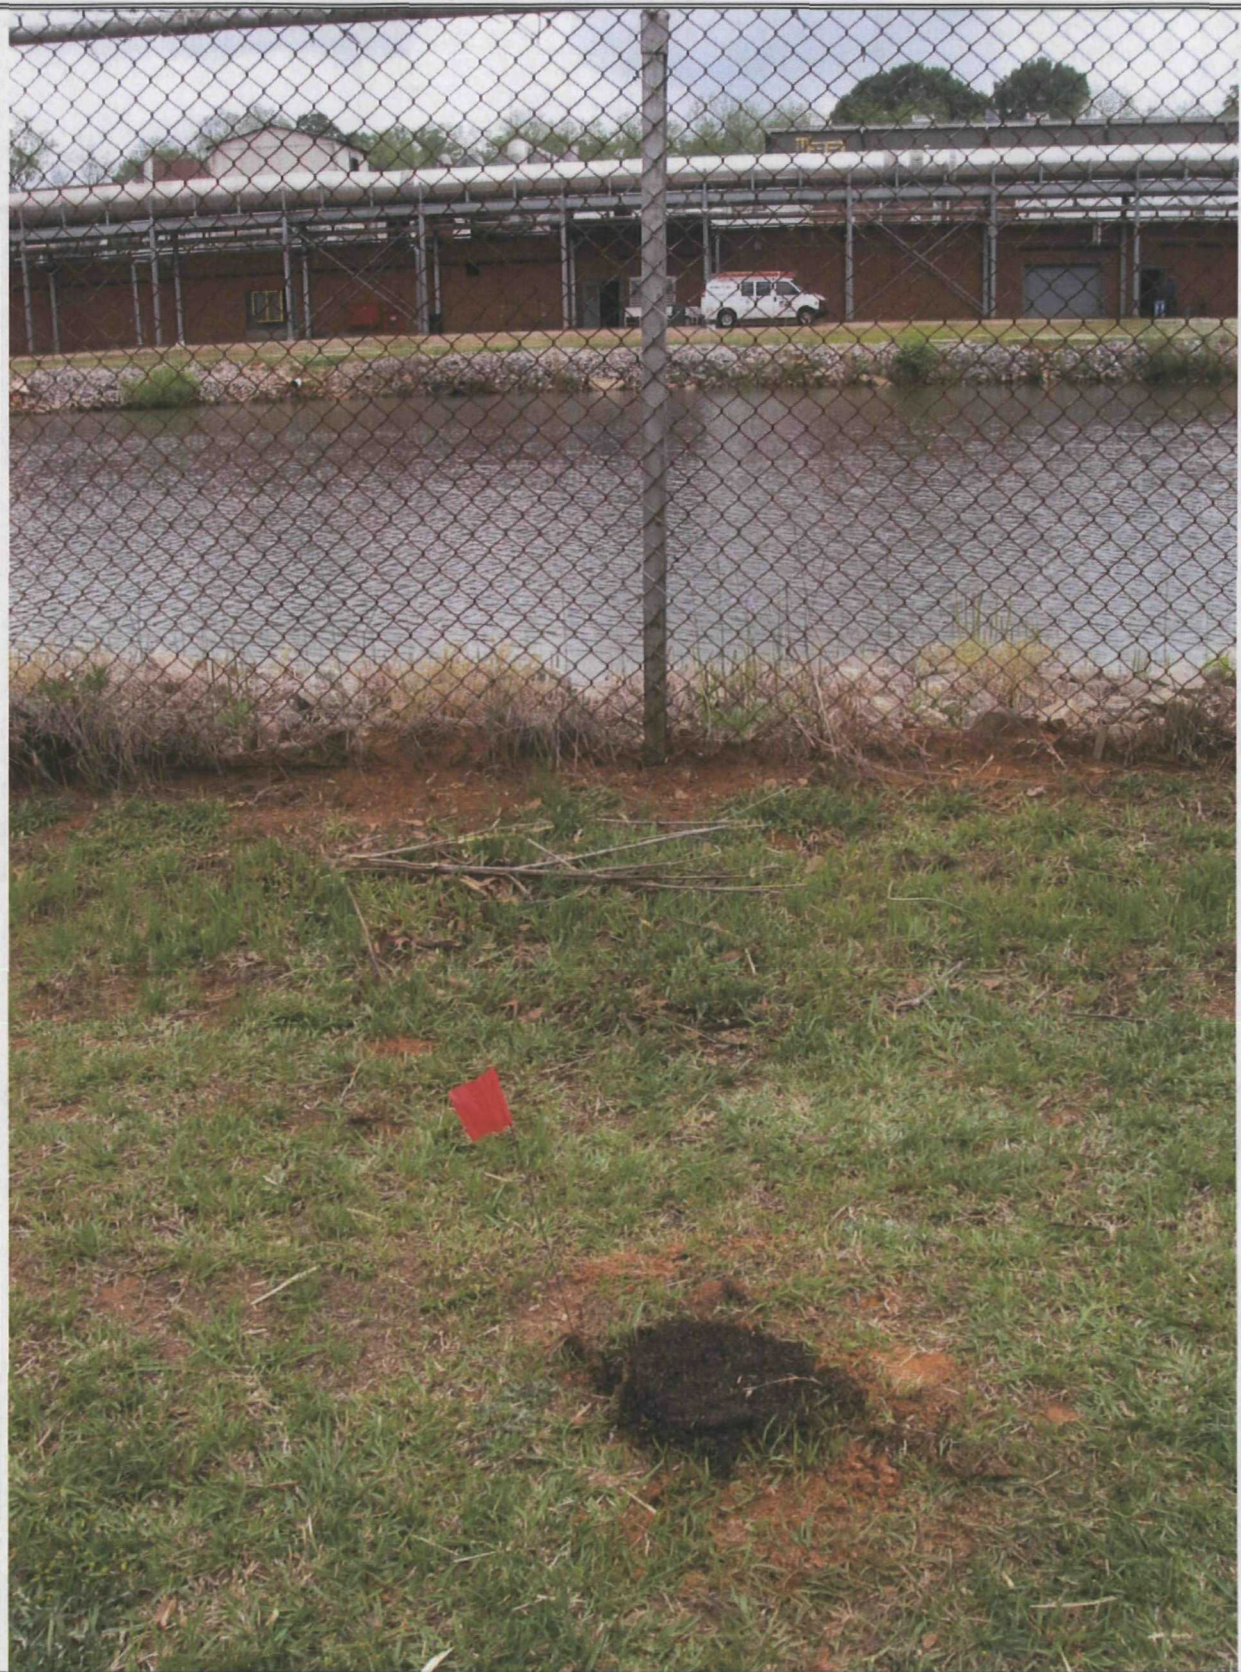
Depiction of immediate vicinity of where surficial soil sample was collected from on-site Sample Station No. STA-22-SS (HW11005).

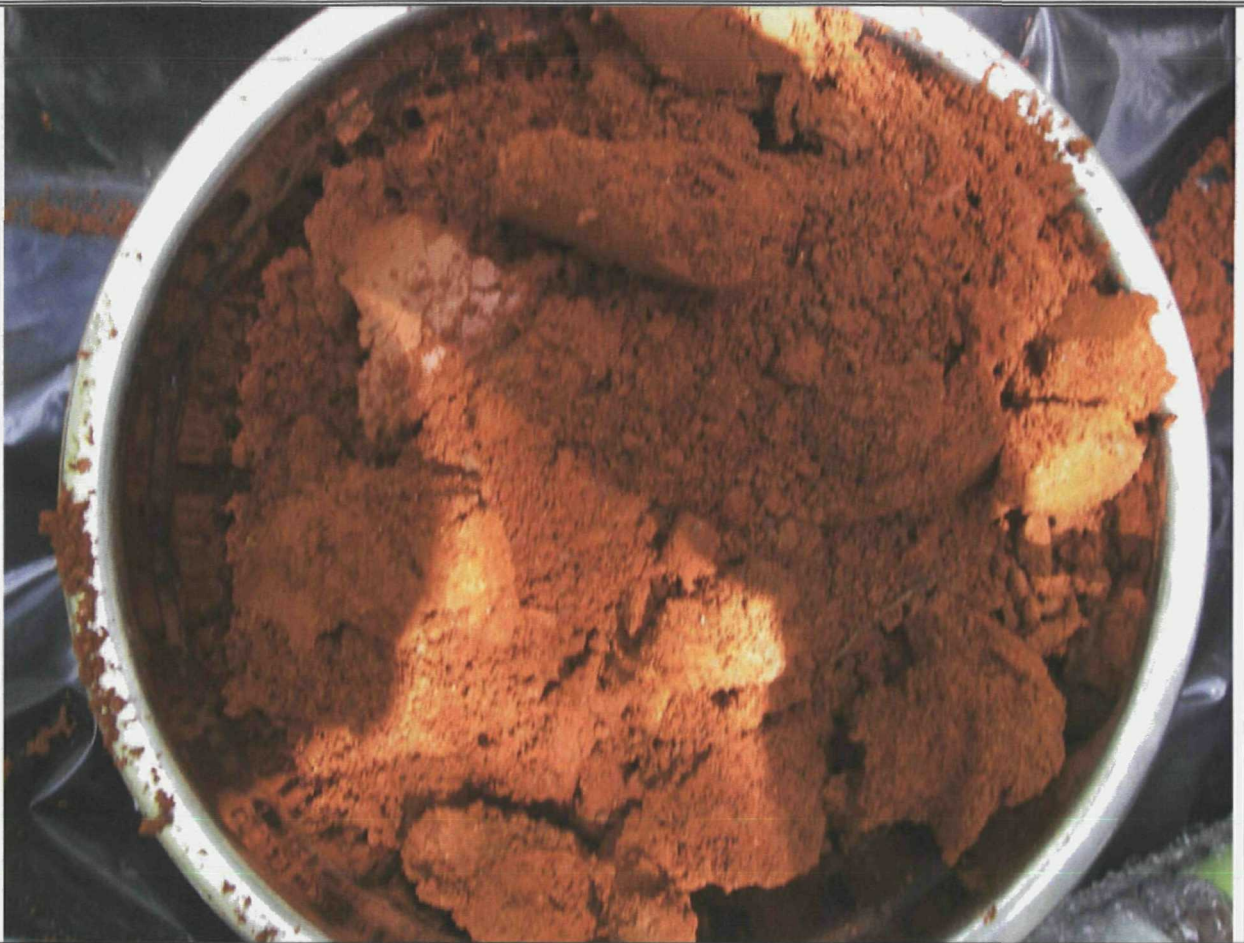
Depiction of surficial soil sample matrix collected from off-site Sample Station No. STA-17-SS (HW10999) located in Granger Park.

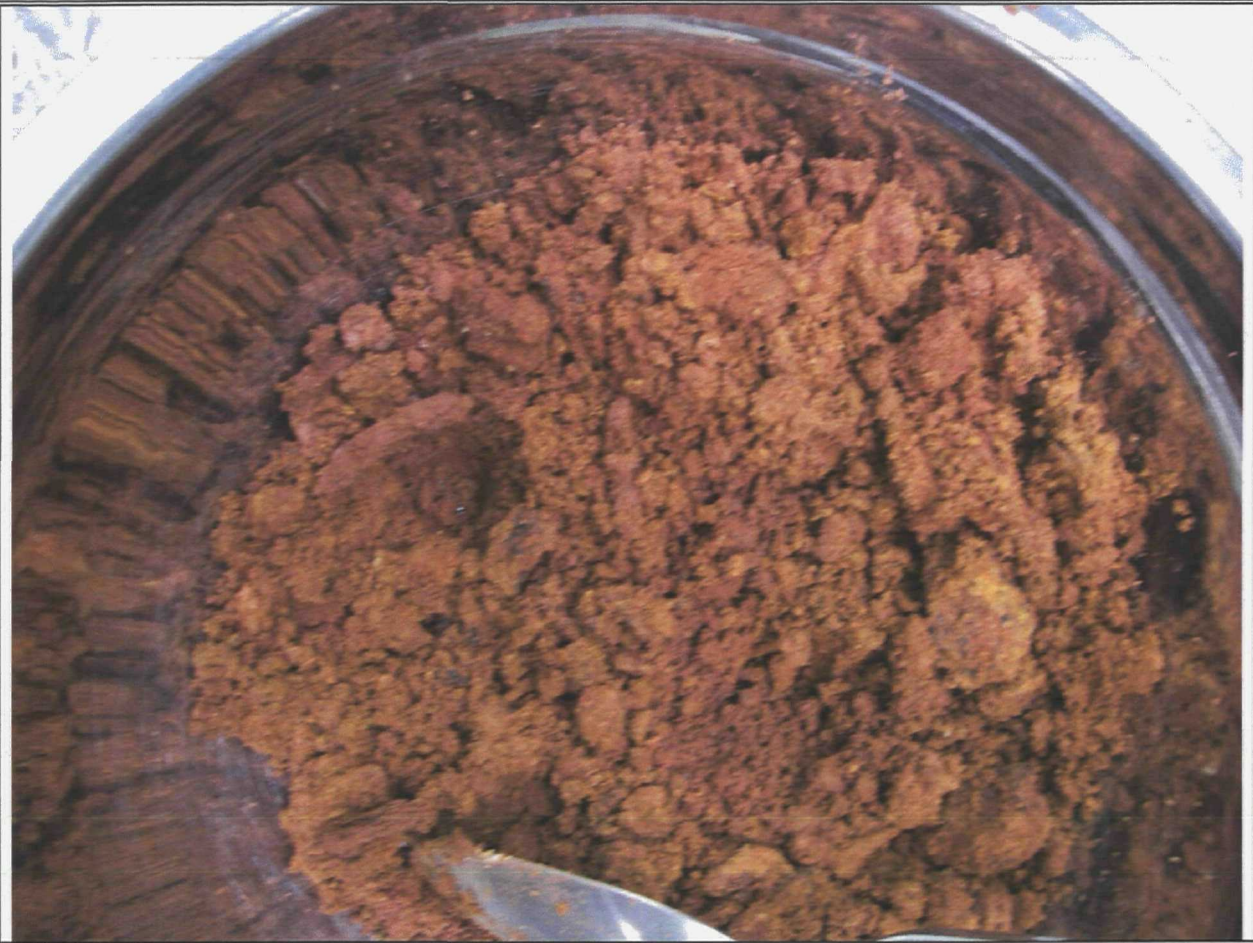
Depiction of subsurface soil sample matrix collected from off-site Sample Station No. STA-17-SUB (HW11000) located at Granger Park.

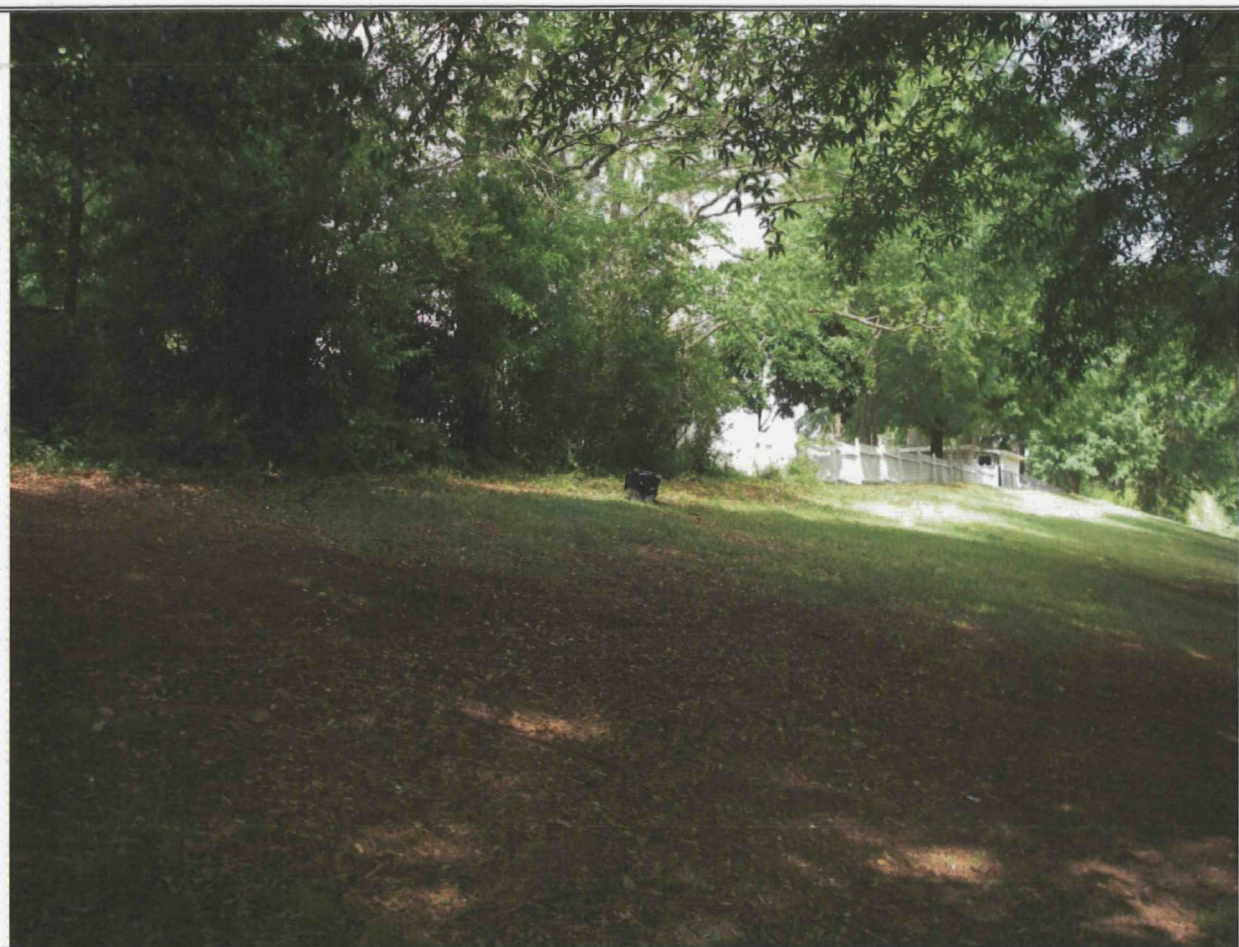
Depiction of general vicinity of where surface and subsurface soil samples were collected from off-site Sample Station Nos. STA-17-SS and STA-17-SUB respectively (HW10999 and HW11000 respectively) located at Granger Park.

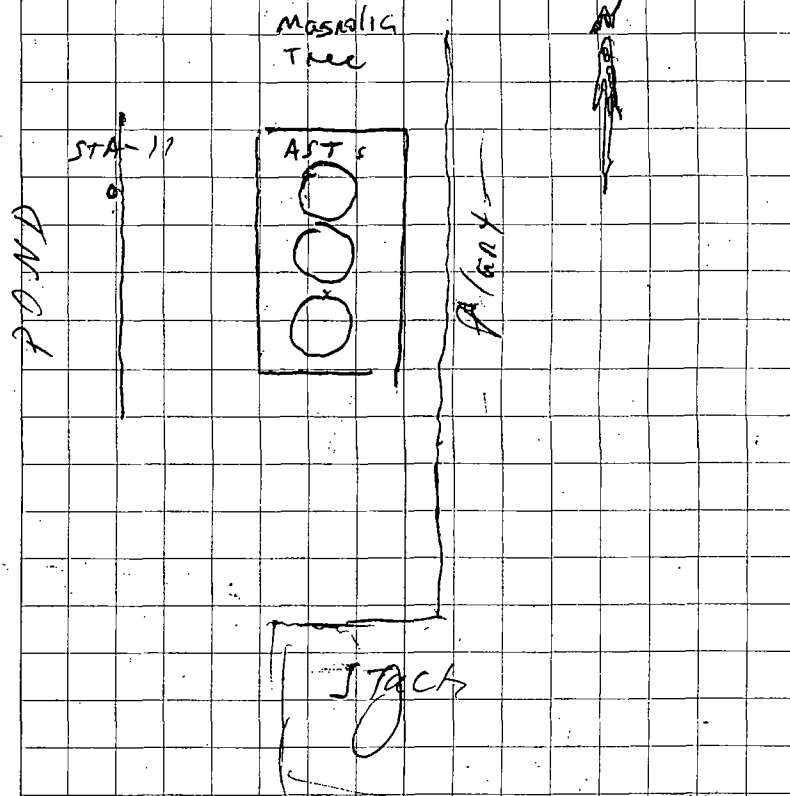
STA-11 Notes

Collected Sediment Sample using
spoon from b/wm. Cracks b/wm
concrete rip rap on pond bank
